Failure Analysis of Connecting Rods and Engine Blocks of Small Generators

Kabiru Bashir¹, I. Y. Tokarawa², Musa Hassan Muhammad³

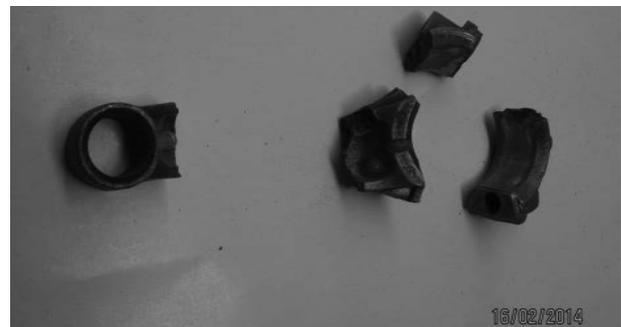
PLATE 1 FG1 Connecting Rod

- 1- FG 1 (2.7kVA, SG2700) below is the first generating set selected for the investigation. It was narrated by the owner of this generator that it was purchased and commissioned in October, 2010 and failed in June 2012. After examining this generator, it was observed that the connecting rod broke into small pieces. The broken parts hit the engine block and made two holes on the side of the engine block. In addition, part of the piston was broken. Plate 4 shows the holes on the engine block.

a) The failure of this generator was triggered by the catastrophic failure of the connecting rod which broke into small pieces. The broken pieces of the connecting rod pierced the engine block making a big hole. Chemical analysis of the Connecting Rod revealed that it was made of Aluminium alloy of 95.80% Aluminium, 2.37% copper and 1.32% iron. Most useful alloying elements for Aluminium are copper, silicon, manganese, magnesium and zinc. (Jain, R. K. 2009) The copper content is only 59% of the minimum AA

and BS standards of 4.0%. This coupled with a high iron content of 1.32% made the connecting rod harder and therefore more brittle and more susceptible to fatigue failure because of the cyclic stresses on the connecting rod.

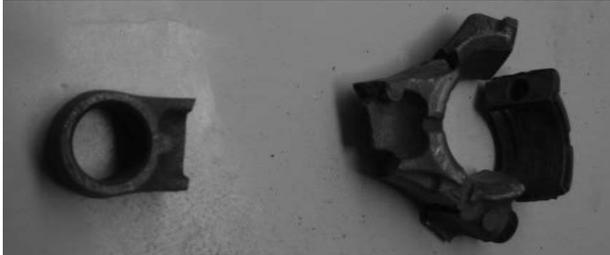
PLATE 2 FG2 Connecting Rod

- 2- FG 2 (2.7kVA, TG2700, TIGER) is the second generator that failed about two years after commissioning while it was in operation. After

it was dismantled, it was observed that, the connecting rod broke into four pieces and the piston was damaged due to the scratches over its surface. Similarly, the engine block was pierced with many holes.

- (a) (i) The connecting rod broke into four pieces which lead to the catastrophic failure of the generator. The broken pieces made two holes in the engine block. Chemical analysis of the Connecting Rod showed that it was made of 95.05% Aluminium, 1.93% copper, 2.01% iron,

0.59% zinc and 0.24% manganese with traces of nickel and titanium. The copper content is 48% of the AA and BS standards. The low copper content together with high iron content of 2.0% made the alloy hard and brittle causing premature fatigue failure

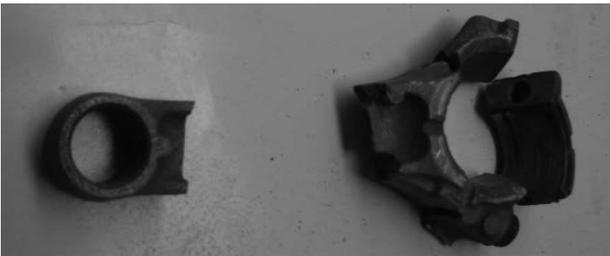
PLATE 3 FG3 Connecting Rod

3- FG 3 (2.5kVA ELEPAQ, EC2500CXS) is the generator that worked for twenty months before the failure. It was observed that, the connecting rod was broken into pieces. However, the engine block was not damaged. See plate 3 for broken connecting rod.

Failure of the generator was caused by the breaking of the connecting rod into four pieces. However, the engine block was not damaged.

- (a)(i) Chemical Analysis of the Connecting Rod showed that it was composed of 95.69% Aluminium, 1.77% copper, 0.99% iron, 1.27% zinc with traces of tin and lead. The copper content was 44% of the minimum recommended by AA and BS. Iron content of 0.99% and zinc content of 1.27% helped to increase strength but lack of manganese and magnesium probably encouraged fatigue failure.
- (a)(ii) The Engine Block was made of 95.38% Aluminium, 2.01% copper, 1.65% iron and 0.20% manganese with traces of zinc, nickel, titanium, zirconium and lead.
- (b) Hardness of the Connecting Rod and Engine Block. Hardness values of the Connecting Rod was found to be 175BHN which was

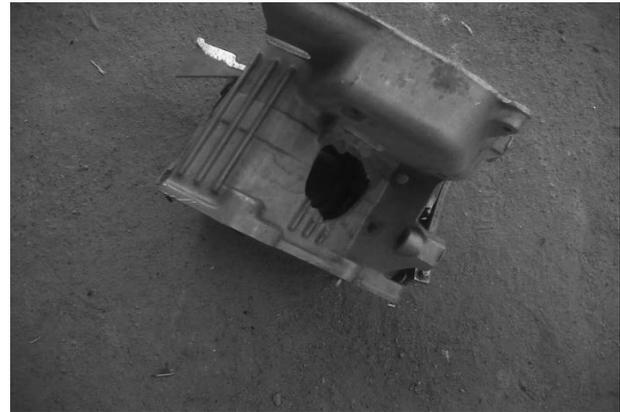
PLATE 4 FG1 Engine Block

- b) The Engine Block contained 94.56% Aluminium, 1.27% copper, 1.90% iron and 1.40% zinc. The copper content is only 32% of the minimum recommended in the AA and BS standards. This together with high iron content of 1.90% made the engine block very hard and brittle, even though the zinc content of 1.40% should have promoted the strength. The chemical analysis showed no trace of manganese or magnesium which could have improved the strength as in Duralumin.
- c) Hardness of the Connecting Rod and Engine Block were 160 and 128 BHN respectively, much higher than the maximum 105 BHN recommended by AA and BS standards which contributed to the brittle failure of the Connecting Rod and Engine Block.
- d) Tensile strength of the Engine Block was found to be 167 kN/mm² (MPa) which was 1.8% lower than the AA and BS standards of 170 MPa.

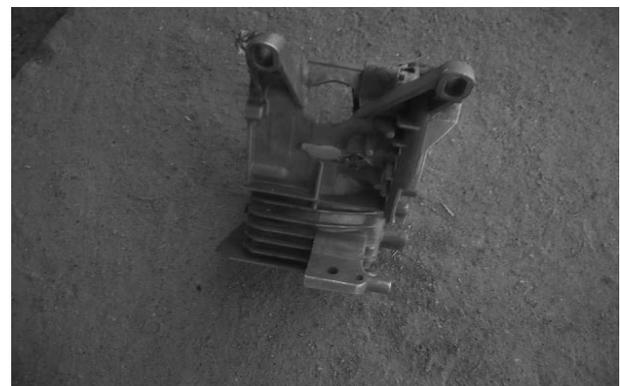
PLATE 5 FG2 Engine Block

- (a)(ii) The engine block was made of 95.47% Aluminium, 2.01% copper, 1.56% iron, 0.62% zinc and 0.12% manganese with traces of nickel, tin, titanium and lead. The copper content is 50% of the minimum recommended content of 4.0%. The high iron content of 1.56% made the connecting rod hard and brittle prone to fatigue failure.
- (b) Hardness of the Connecting Rod and Engine Block The hardness of the connecting rod was 151 BHN which was much higher than the maximum standard value of 105BHN making the component more brittle and therefore highly prone to fatigue failure. The hardness of the Engine Block was found to be 160BHN much higher than AA and BS standard values of 105BHN.
- (c) Tensile strength of the Engine Block was found to be 149 kN /mm² (MPa) which was 12.4% lower than the AA and BS standards of 170 MPa.
