# Anjan hill mine explosion: human failures resulting 14 fatalities

**Keywords:** Underground coal mine; explosion; human errors; human factor analysis and classification system (HFACS).

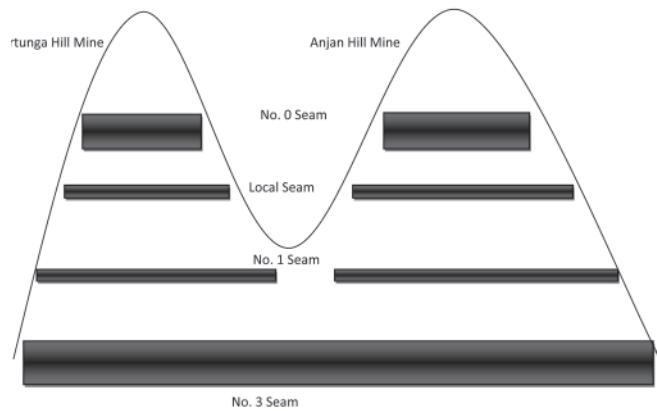
Fig.1 Vertical section showing the seams

There were four workable coal seams in Anjan hill mine leasehold area namely 0 seam, local seam, no.1 seam and no.3 seam and are depicted in Fig.1. No.3 seam was the bottom most seam where explosion took place.
