# Decontamination of a dumpsite of waste from mineral oil refineries in the Czech Republic, locality of Ostrava

*Oil lagoons in Ostrava contribute significantly to environmental contamination in the Czech Republic. In the lagoons, liquid and solid waste from a mineral oil refinery was deposited for a long time. In the contribution, the authors are concerned with the description of a procedure for removing the content of the lagoons, remedial measures and use of decontaminated areas.*

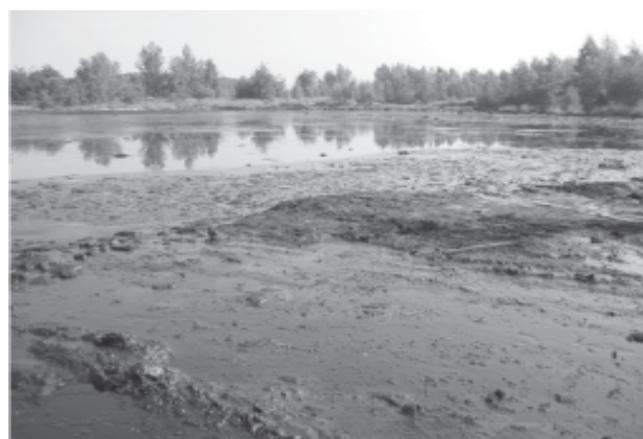
Fig.1 General view of the locality of Ostramo lagoons in Ostrava

There are places that would be best forgotten. Localities that seem to have never existed. These areas are many times referred to as old damage. People put off their preparation and tried not to see, not to handle, to forget. But they remained, the problem did not go away, it only slowly and inevitably grew bigger. Such old damage includes among other places also places located in the Moravian-Silesian Region. In this part of the Region on the cadastral territory of Ostrava-Mariánské Hory and cadastral territory Ostrava-Privoz, City of Ostrava, District of Ostrava-Mesto there is a waste dumpsite. It is known as a waste disposal site of s.p. DIAMO, from the past better known as so-called Ostramo lagoons in Ostrava (Fig.1).

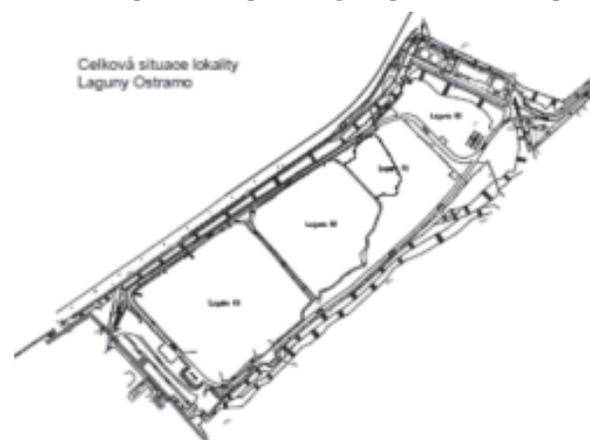
Fig.2 General layout of the locality Ostramo lagoons in Ostrava

The waste dump is located within the range of lagoons marked R0. This is the oldest lagoon, in which semi-solid waste was detected under the landfill. It is not separated with an underground supporting wall ("Milan" wall). Lagoons R1, R2, R3 located at with "Milan" underground walls on the perimeter. Their purpose was to isolate the surrounding environment and function as a seal. Insulation function of Milan walls, like other man-made works, is limited in time and therefore requires reconstruction, separation of the lagoon, (Fig.2). The lagoons are located in an industrial zone on the right-bank side of the alluvial plain of the river Odra and border on Mariánskohorská

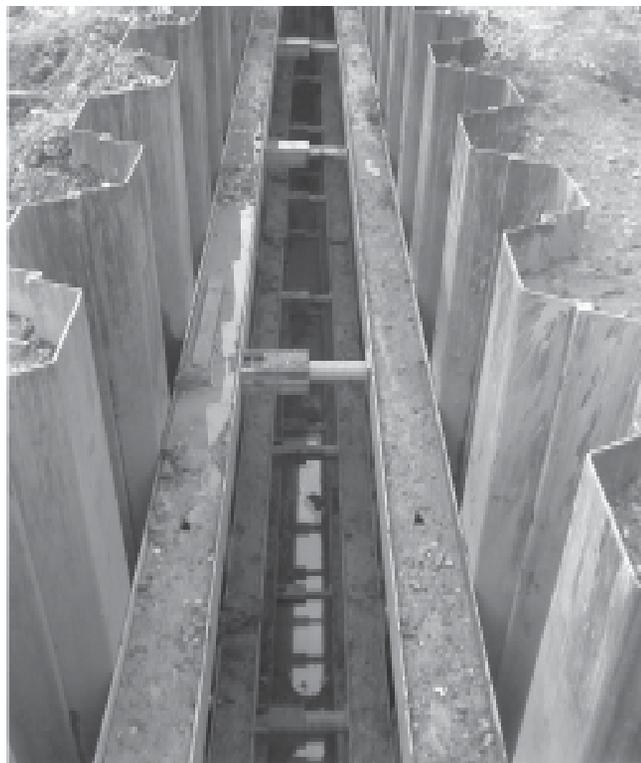
Fig.3 Construction of excavation for a drainage rib supported by sheet pile walls

A drainage system for decontamination of the territory, (Fig.3), was built at the lagoons during implementation of emergency remedial measures. This system was efficient and it was necessary during the construction of the drainage rib to comply with safety measures in connection with detected presence of methane [3]. It was necessary to have specialized safety supervisors present and get informed about the methane risk in the given locality. It was necessary to observe and comply with the quality of backfill material used, its compacting during the construction of the rib. Then lowering of groundwater level was monitored during decontamination pumping to prevent movement of contamination further down to less contaminated terrace gravel. Extraction was done in decks (levels) and soil was closely monitored all the time from the contamination point of view. Heavily contaminated soil was separated from less contaminated soil. The process of pumping water from the pit was monitored to prevent spreading of contamination by water. After the backfill of the drainage rib, contaminated soil was extracted from a strip between the rib and the CD trackage. The contaminated soil was accumulated at the decontamination plate for liquidation.

Work was performed in six sections, which were prepared beforehand according to work schedule and each was closed by a transverse wall. Maximum level of excavation was always 0.5 meters under then installed level of spreading structure. One spreading structure was installed at one level and subsequently excavation at the lower level was performed. On the other hand the spreading structure was removed, which was done upon completion of backfill up to the next level. By building the sheet pile walls it was possible to build a drain for which a trench was made. Excavation of the trench using earthwork support and levelling of the trench bottom enabled subsequent installation of drainage pipes at two levels. The drainage pipes were subsequently controllably covered with drainage material. The drainage rib was filled with crushed aggregate (gravel) of 32 - 63 mm fraction at two levels of height. Pumping and inspection manholes were built under the protection of walls. Inspection pumping concrete sumps were spaced 60 meters apart and placed in the line of the rib. They were made of pre-fabricated parts equipped with a ladder on the inside. The prefabricated parts were 800 mm in diameter. The height of the tops of sumps had to be aligned with the surrounding terrain and they were covered with steel lids, which were lockable. Larsen-type sheet piles were used in the locality. Pipe spreaders were used for strutting, which through a strap anchor enabled gradual excavation of the trench. Rams were diesel-powered, high-frequency non-resonant and vibration type. High-frequency types are conveniently used namely for redevelopment work in built-up areas.
